# REPORT

## INTERMÉDIAIRE D'OPÉRATION D'ARCHÉOLOGIE PRÉVENTIVE

WWII aircraft wreckage removal and Missing US Airmen (MIA) research, under guidance of the  
Insutute of National Research of Archaeology (INRA) the Luxembourg Ministry of Culture

“WindGen Site”, 2021  
activity No: 2021-034

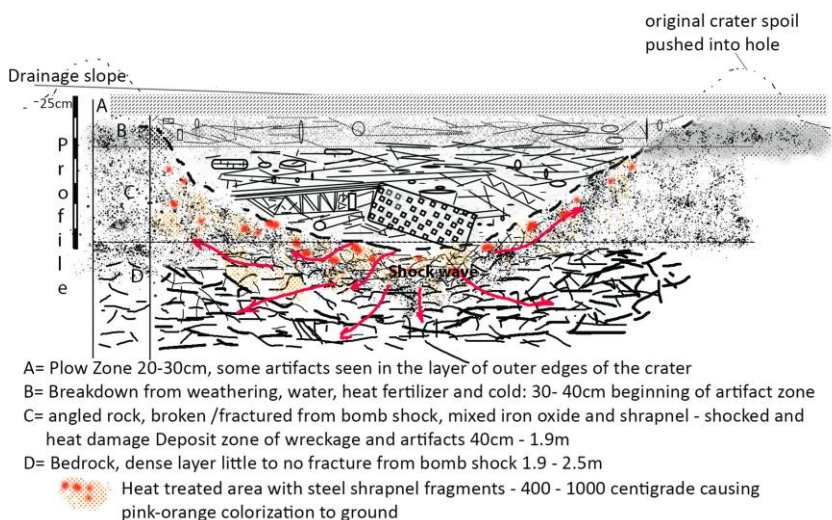
Fig 6-2, illustrates ground changes, Munsell scale 10YR, 6/6 - 5/8, WWIIBRPG

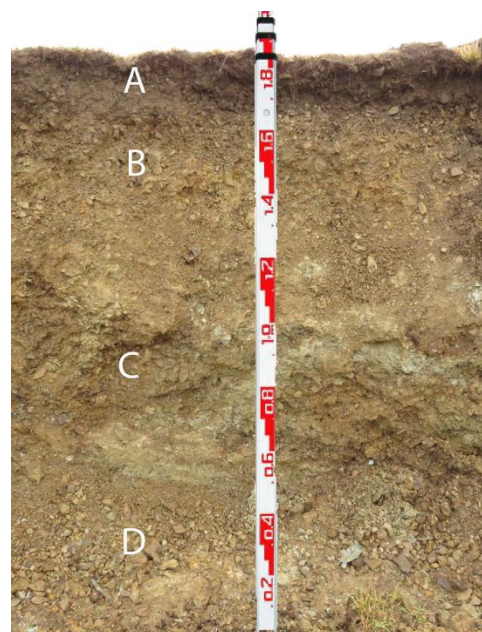
Fig 6-1, USBC Profile with ground shock damage, WWIIBRPG

The North Ardennes locally called the Eisleck or Oesling geology has been a dynamic subject since the beginning of the Ardennes Offensive began on 16 December 1944 when the tactics were to move armies, tanks, and other heavy equipment over the steep hills and deep valleys with very little or no paved roads. Consisting largely of Devonian schists, shales, sandstone clays, and quartzite's of 400 million years ago, the weather and topography play a primary role in soil development or lack of. At the Draï Hivelen, the site area is open crop fields with barely 25 to 30cm of topsoil commonly called the "plow zone". There are other factors that also play part in the degradation of aircraft metals, plastic, rubber, electronics, laminated phenolic, and pressed board. The amount of fertilizers over time and water drainage or how much water stays in the ground as well as how much comes up from the ground as high water tables. All this can have grave effects on artifacts and evidence. The slope of the site area averages 1m per 100 meters in the SW to NE direction measured for 200m. A profile (Fig 6-1) of the crater exhibits damage done by explosive shock.

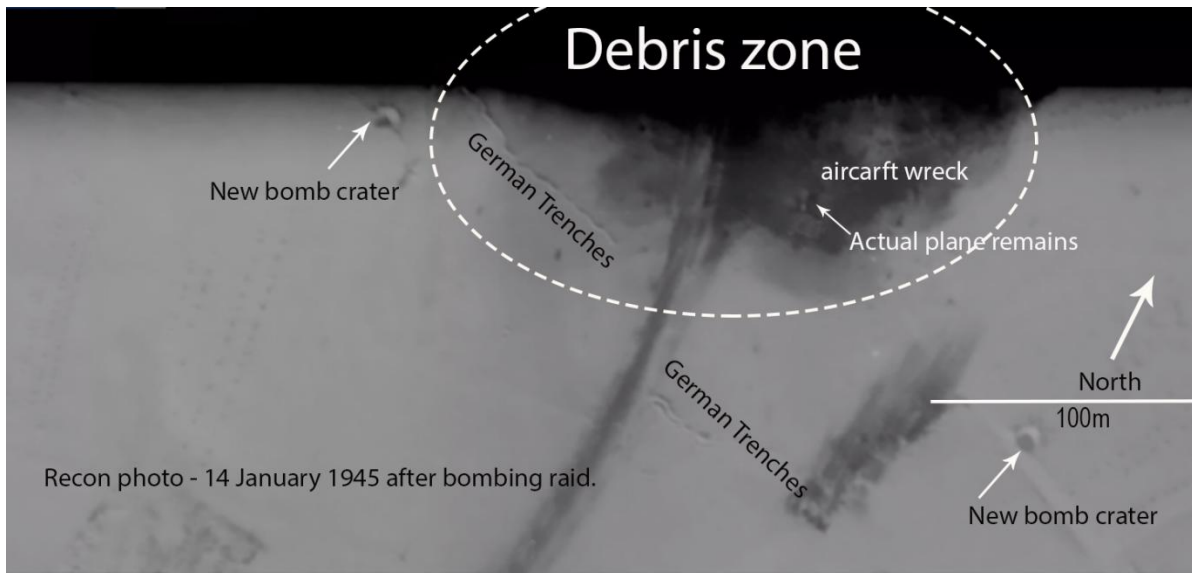
Fig 7-1, Jan 14 1945, NCAP,NARA,WWIIBRPG

As stated earlier, these depressions are craters formed on or about 14 January 1945 when the US 19th Air Forces dropped 500lb (250Kg) high explosive ordnance on German positions occupying the area with gun emplacements (fig 7-1). Seven or eight of these craters that have been located were used for dumping battlefield debris and aircraft wreckage during cleanup operations in the summer-fall 1945 by Swiss Army and civil paid workers. It has been documented and observed that the contents of aircraft wreckage have been subjected to varying degrees of corrosion. Some magnitude of corrosion has been so far as that much of the aluminum has transformed back to a powder magnesium state and also presents itself as a light blue grainy powder and sometimes a liquid gel that is slimy. Obviously buried deeper objects and deposits on more slop have less degradation. The photo shows different metals in the helmet and bomb backplate in condition as compared to aluminum with and without corrosion preventive techniques.

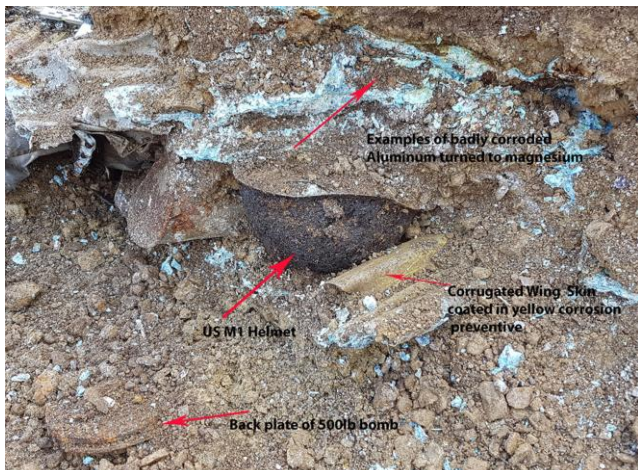
Fig 7-2, iron artifacts verses aluminum

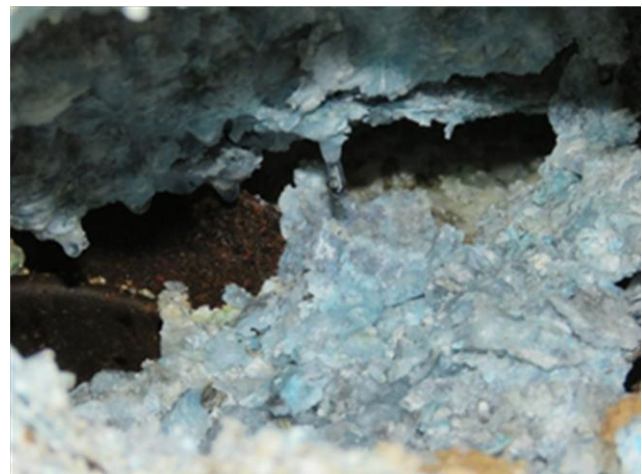
Fig 7-3, US M1 Helmet lies in aluminum remnants

The helmet (fig 7-2) was cleaned and found to belong to an SSgt Casey, 28<sup>th</sup> Division 1<sup>st</sup> battalion. They held the line during the December 16 - 18 fighting in the Fischbach - Hupperdange - Heinerscheid zone. Research is ongoing to reveal more about the man and his part in the fighting.

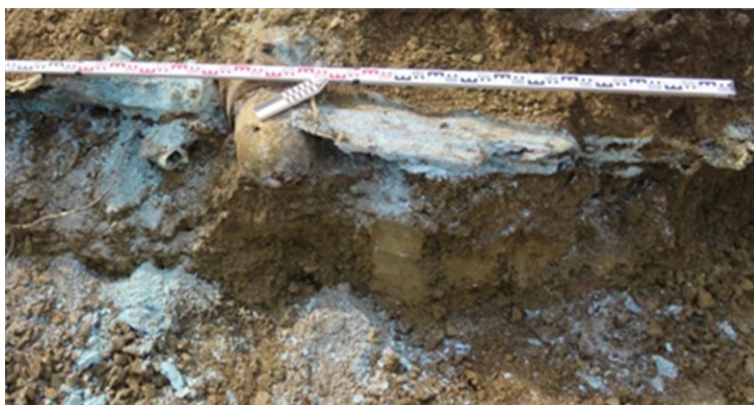
Fig 7-4, Propeller damage from corrosion

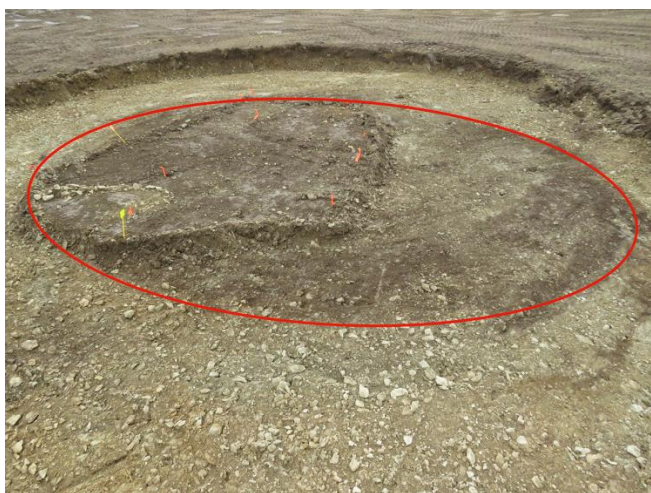
Fig 10-1, USBC-002, filled in the crater in the dark area, WWIIBRPG

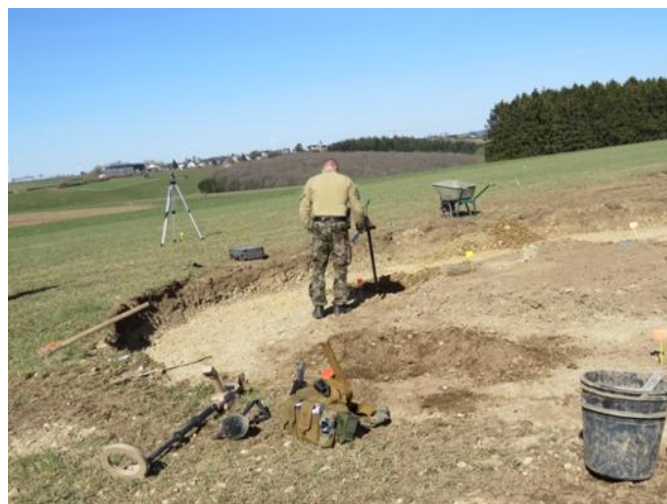
Fig 10-2, USBC002, SEDAL target checking, WWIIBRPG

Designation numbers 2021-034/USBC-001 continuing consecutively were assigned to each depression. Each crater was scanned to determine the size in diameter as well as iron objects greater than 30cm in length and marked in blue paint. Orange flagging was also put out to illustrate the shape and size of the area. An initial de-capping of topsoil of 10cm was taken off. Caution was used as not to scrape directly down on the blue targets. When nothing was observed another 10cm was taken down, this continued until a presence of metals was seen. It was obvious that contents on the edges of the craters would be reviled before areas more toward the center. A central datum point for a site map in Luref was established with elevation (Plan-3). A slope measurement was taken of the field to show an average of .40cm drop to the NE for every 20m. This shows a negligible run-off for water on the site. An additional Luref point was taken in the center of the crater for putting distance in between craters. At this time further scanning of the 50-meter area indicated two additional craters in the immediate area moving in the NE direction. Two craters 7m in diameter were stripped of approximately 40sq meters area.

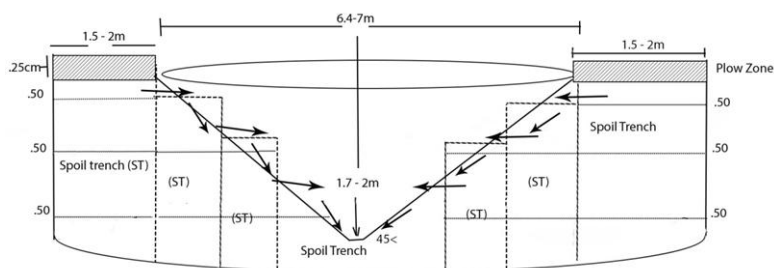
Fig 11-1, diagram of the crater cone as worked, WWIIBRPG

Once the diameter of the crater was well defined and the first contents exposed, a spoil trench of 1.5 – 2m was cut around the crater for the safety of recovering contents from the sides and working downwards, this would repeat as the “pie” shape would begin to shrink and close inward. All the exposing of contents was done by trowel, buckets, and brush (fig 14-2). Small spades were to remove the unneeded spoil and as the trench filled up the spoil was removed by machine and increased the depth until the bottom of the crater reached (fig14-1). Mapping (fig11-3) was done with the aid of measurements from the optical level transit, laser distance measurer and tape, in addition, photos of significant finds and stages were taken to review for a finished map we have no GPR, LIDAR access, or high tech equipment.

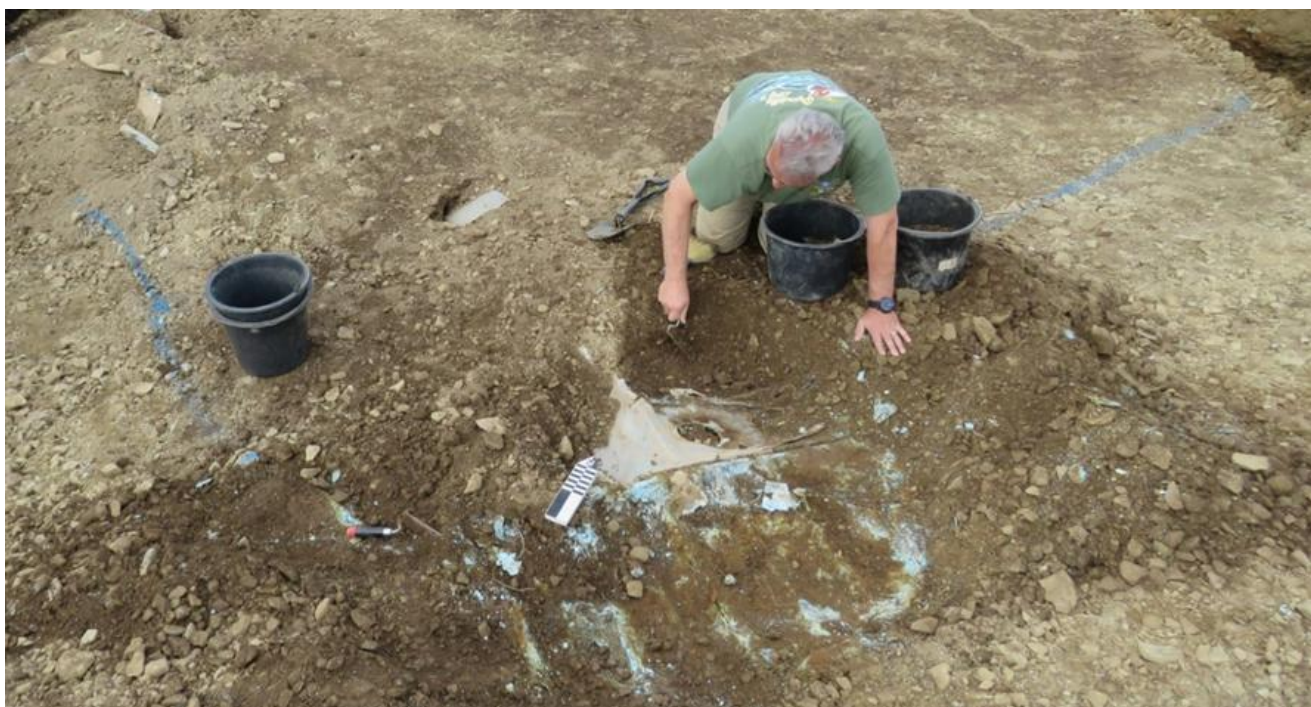
Fig 11-2, exposing, WWIIBRPG

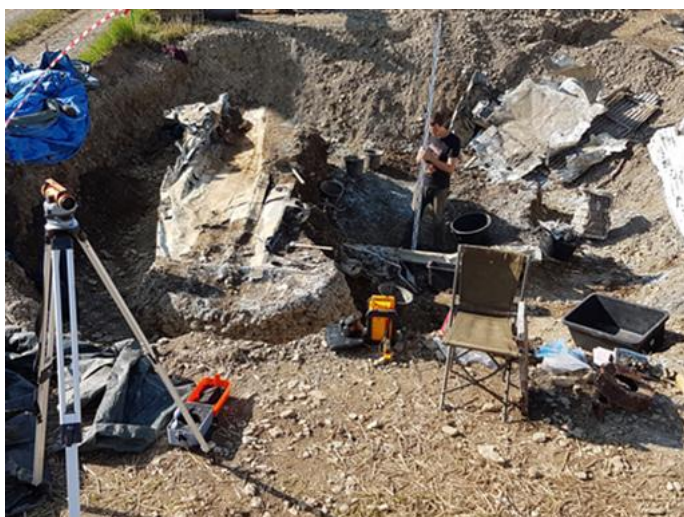
Fig 11-3, center depth reading WWIIBRPG

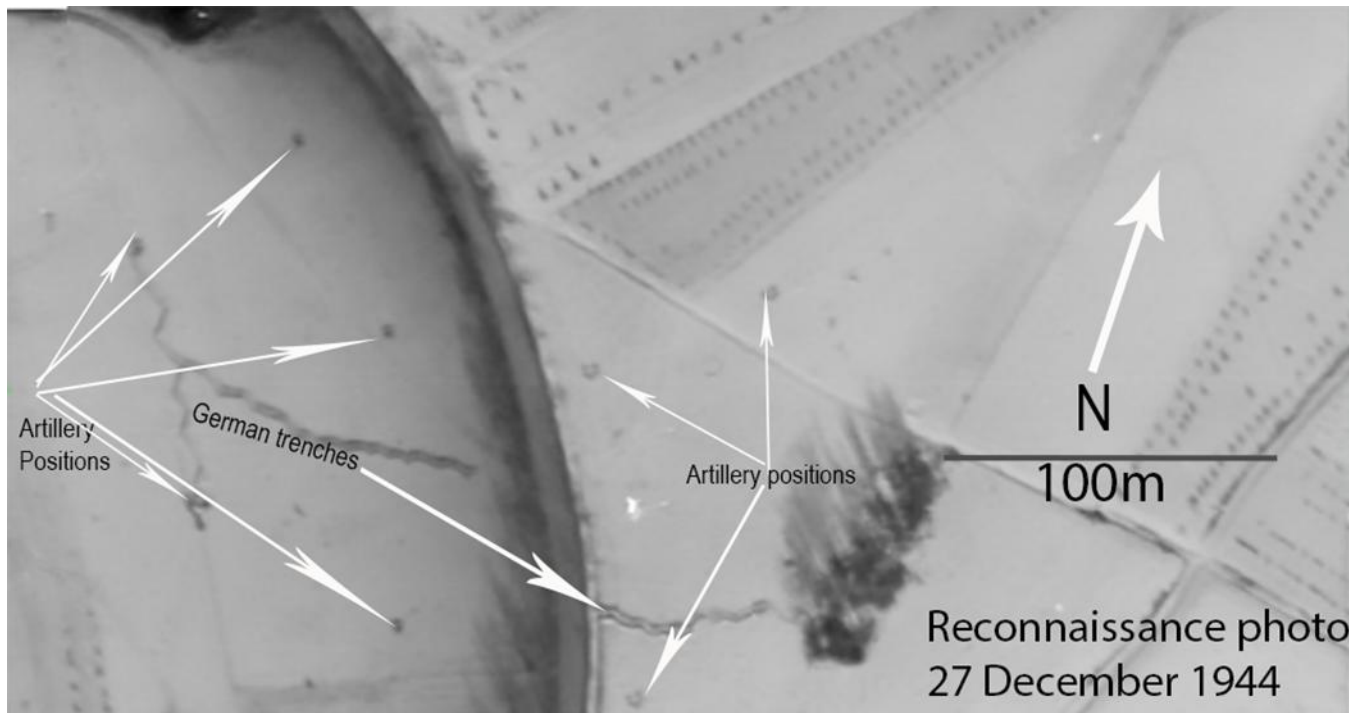
Fig 13-1, 27 December photo shows German positions before bombs dropped on 14 January 1945. NCAP

The aerial reconnaissance photos taken December 27, 1944, and 14 January 1945 clearly show the targets for the US Army Air Forces and the damage inflicted after operations as well as the wreckage of the aircraft in the photos on the ground. The discovery of these crater-filled depressions with battlefield debris and aircraft wreckage indicates a clean-up and salvage mission was being done on the location.

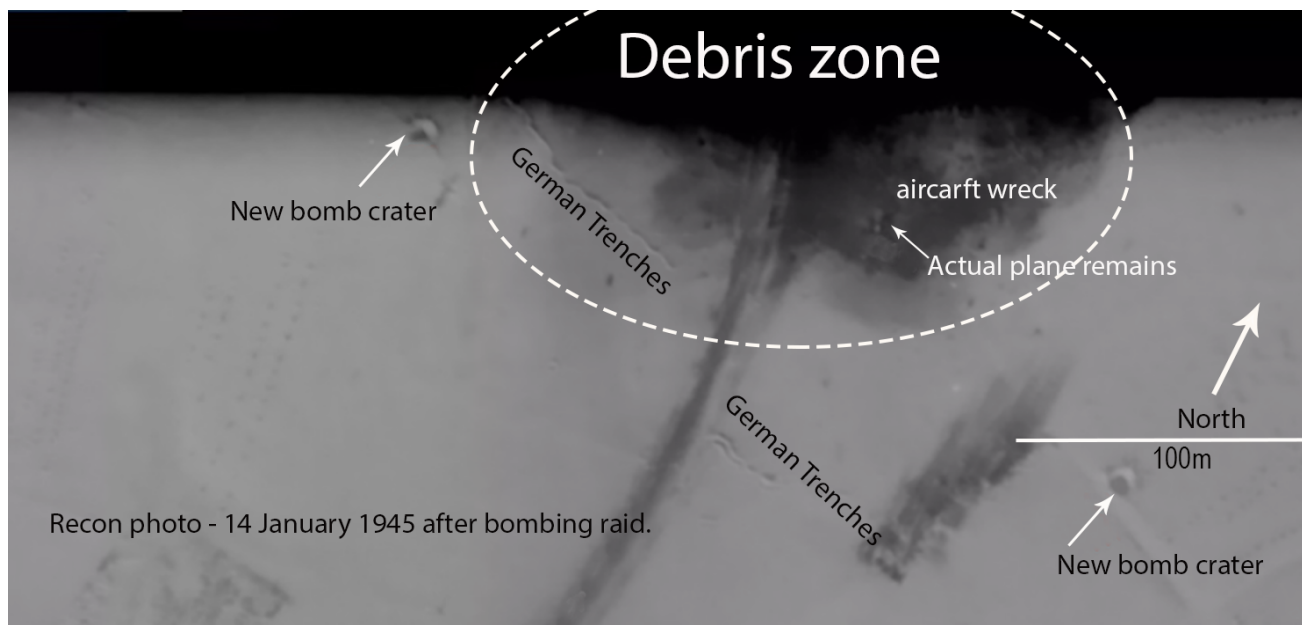
Fig 13-2, shows the same area with snow covered craters from bombing German positions, and aircraft wreckage on the field. NCAP

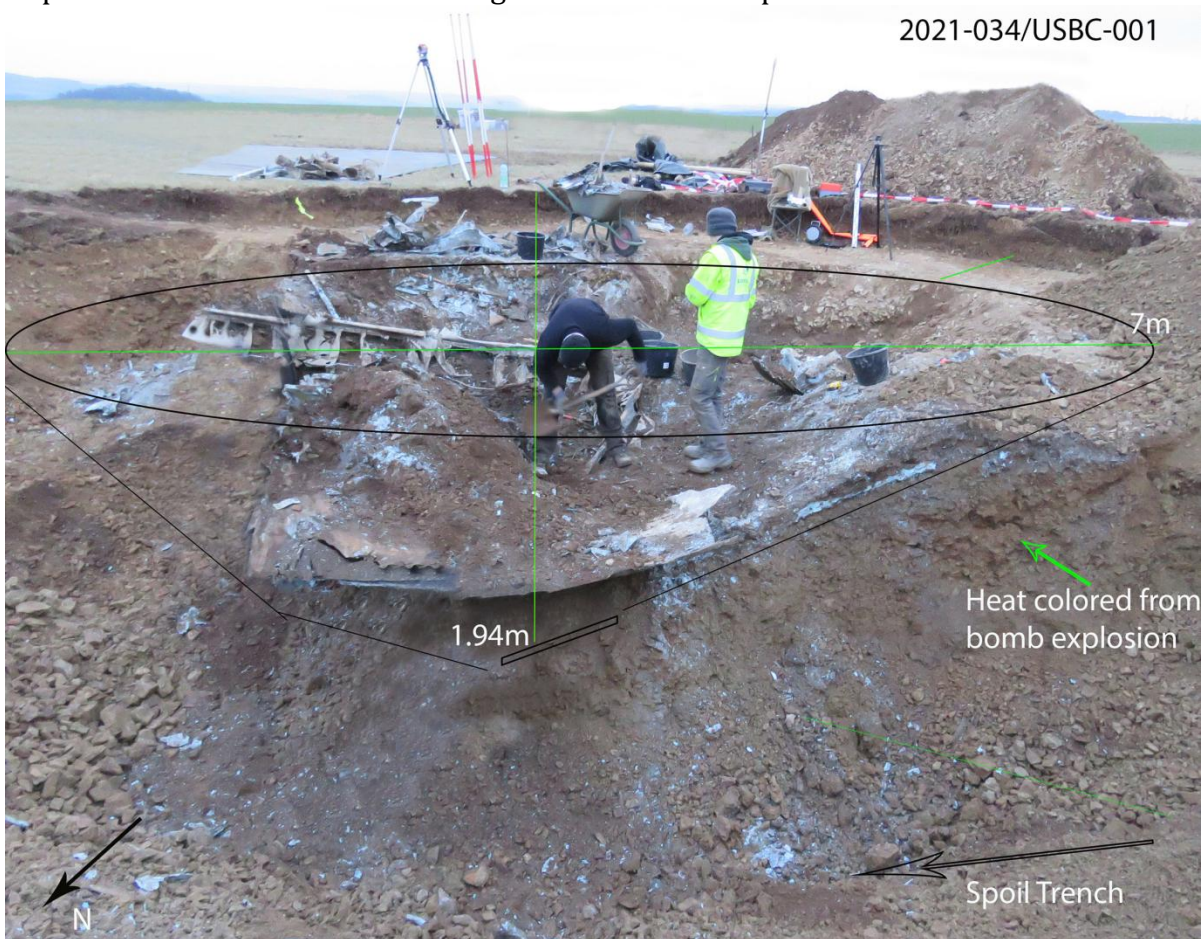
2021-034/USBC-001 - For a detailed map of the site refer to page 15, Map-1  
 Width; 7m in diameter, with spoil trench. 10m = first spoil trench 1.2m, second expansion 1.8, third expansion 70cm  
 Depth - 1.94m in the center. The angle of the cone of depression is about 45°

Fig 14-1, USBC-001 dimensions, WWIIBRPG

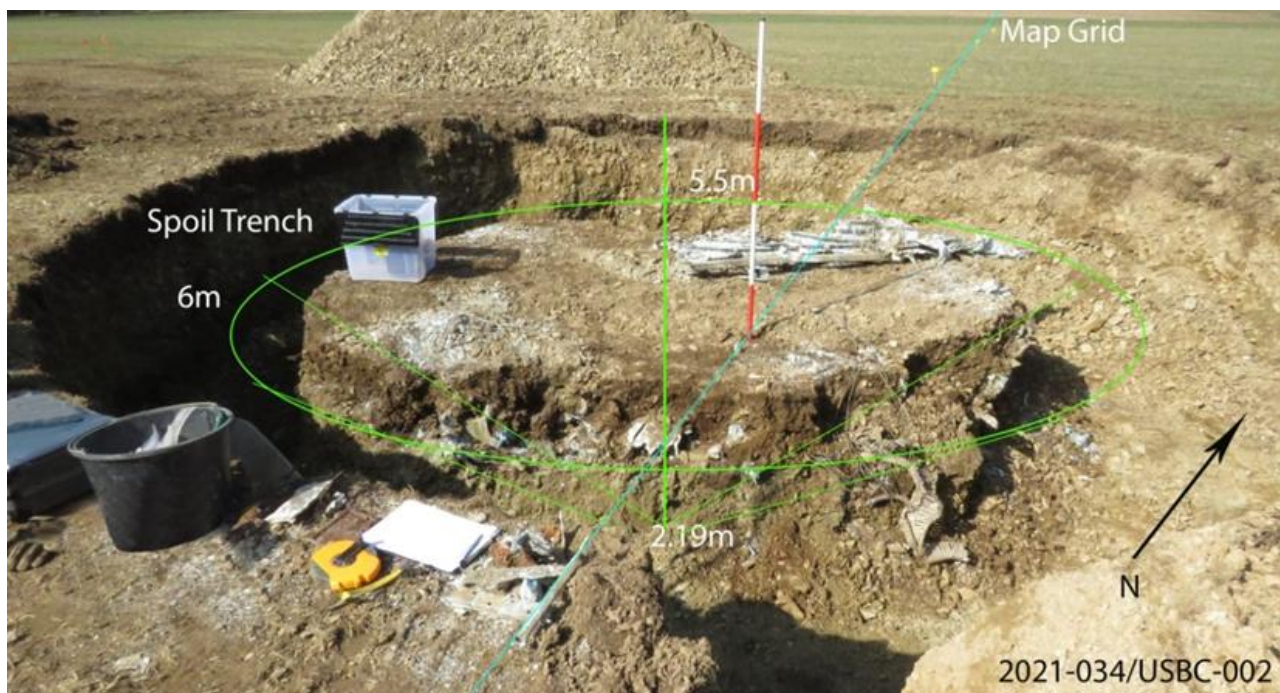
2021-034/USBC-002 - For a detailed map of the site refer to page 16, Map-2.  
 Width - 6x5.5m in diameter, with spoil trench - 10m = first trench expansion 2.6m, the second expansion, 1.4m  
 Depth - 2.19m in the center of the depression, cone angle 45°

Fig 14-2, USB-002 dimensions

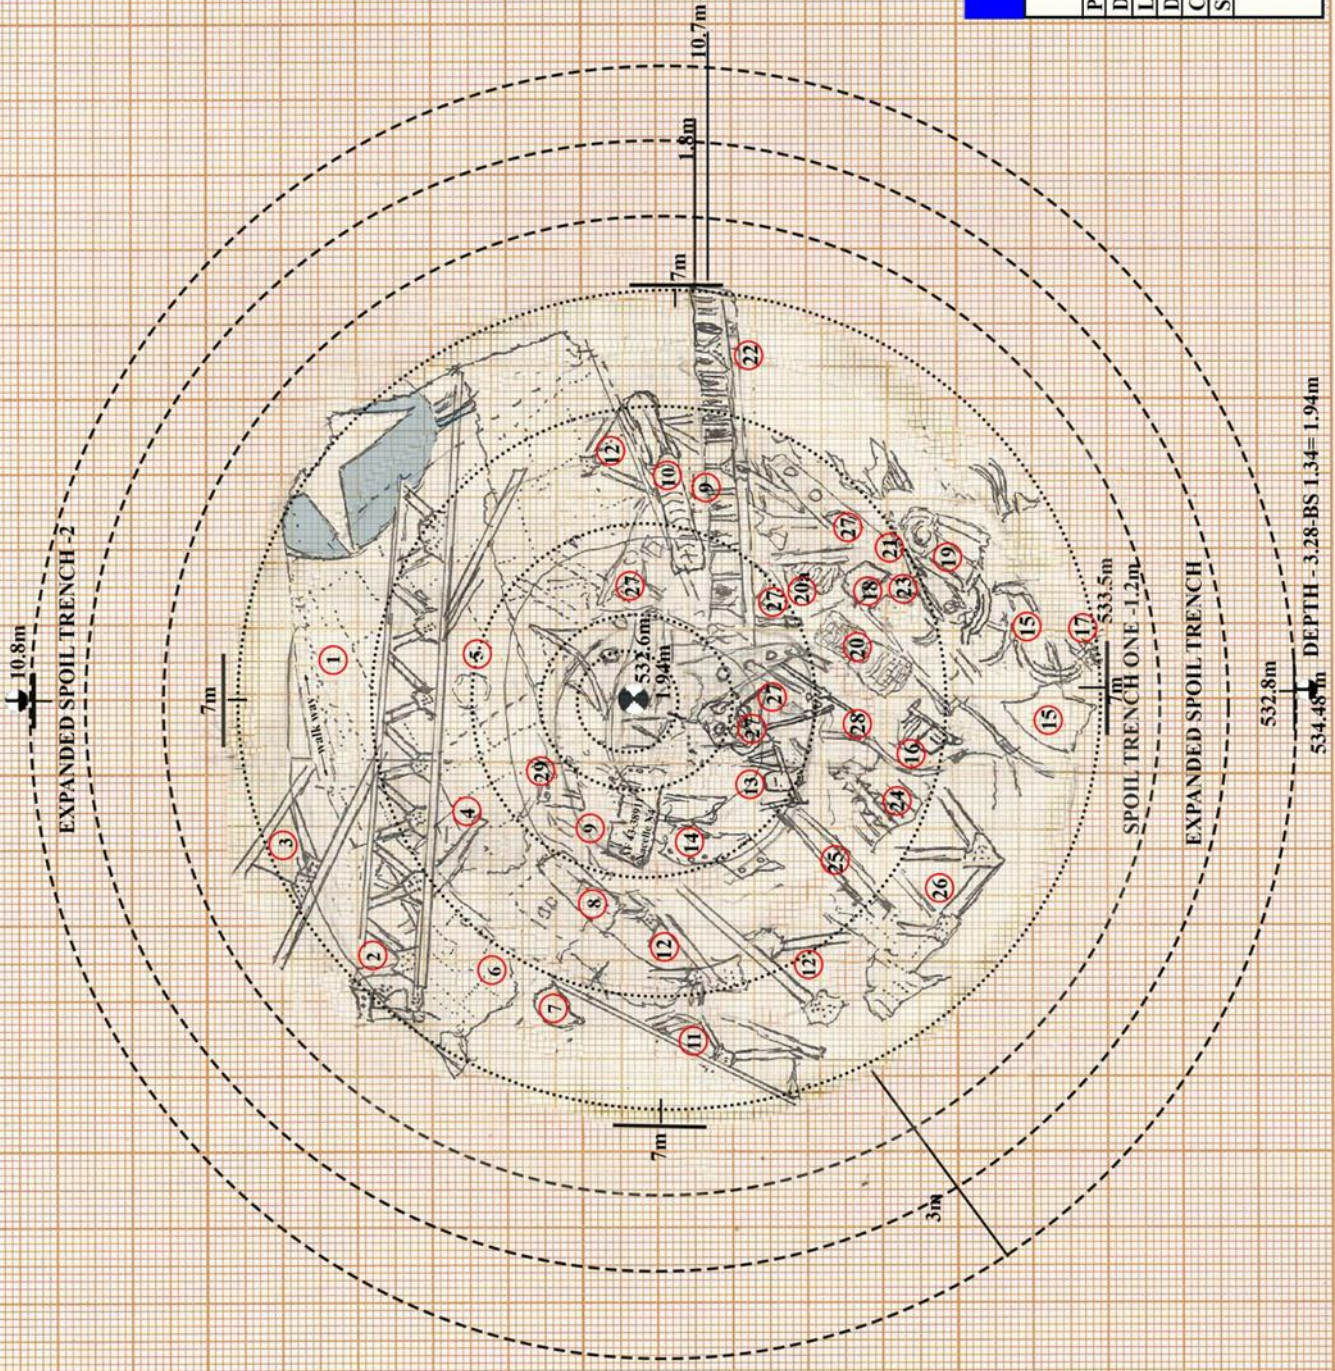
Project No 2021-034/USBC-01: Dräi Hiwelen, Fischbach Commune (Clervaux)

- 2021-034/USBC-1 Primary Artifact Guide
1. WING SKIN W/STAR AND BLUE FIELD
  2. INBOARD WING TRUSS AND SPARS
  3. WING TRUSS FRAGMENT END - OUTBOARD
  4. FUEL BLADDER SUPPORT RIB
  5. OUTER WING SURFACE SKIN
  6. SURFACE SKIN FUSELAGE
  7. MI HELMET - 28TH DIVISION
  8. DYNAMOTOR - VOLTAGE AMPLIFIER
  9. NACELLE COVER - AF-43-3891I NACELE No4
  10. EXHAUST COLLECTOR
  11. OUTBOARD TRUSS SPAR
  12. TRUSS ANGLE SUPPORT WEB-PLATING
  13. RUDDER PEDALS-2, PILOT-CO-PILOT
  14. ENGINE COVER
  15. BALL TURRET FRAGMENT
  16. RUDDER PEDAL PILOT-CO-PILOT
  17. ELECTRONICS - BOX
  18. FLAK HELMET
  19. BOMB FINS - 500LB
  20. 20a. FLAK VEST - X2
  21. TYPE-1 SERVICE SHOE
  22. AILERON - STARBOARD
  23. AILERON - FRAGMENT PORT-SIDE
  24. WING SKIN - SUPPORT
  25. FUSELAGE STREAMER SUPPORTS
  26. WING TRUSS SUPPORT SECTION
  27. INTERNAL WING RIB SUPPORT
  28. FUEL LINE - RED BAND COLOR CODE

Depth: 1.94 m, contour interval .50cm. Benchmark 534.48m - 340< North

Crater width - 7m x 7.2m Datum point

Spoil Trench width 3.8m - 2.8m Measure point

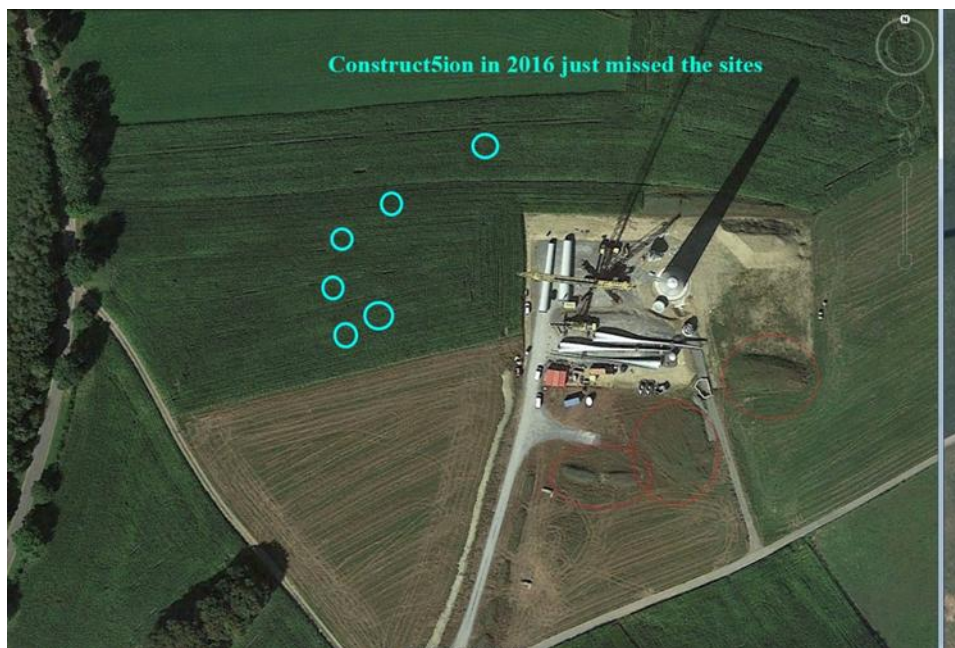
Fig 18-1, Geoportal, WWIIBRPG

Contents of the deposits in “entire” are paramount to finding conclusive evidence to possible MIA localities. Items that could shine light are ID tags from any one of the missing men, top turret parts from the aircraft, or bone fragments. It was also said that when the wind turbine was built the construction crews had come across “some” wreckage fragments. What and how large this was no one knows, we are looking into it. Photographs of the replacement generator show that the site only missed the deposits by 30m.

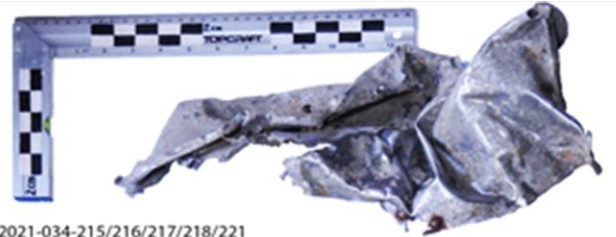
Plt - 12, Engine cover flak damage

2021-034-215/216/217/218/221  
Nacelle covers, shrapnel damaged

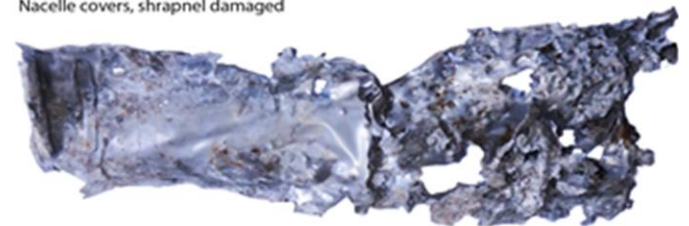
2021-034/219  
Oil Cover,damaged

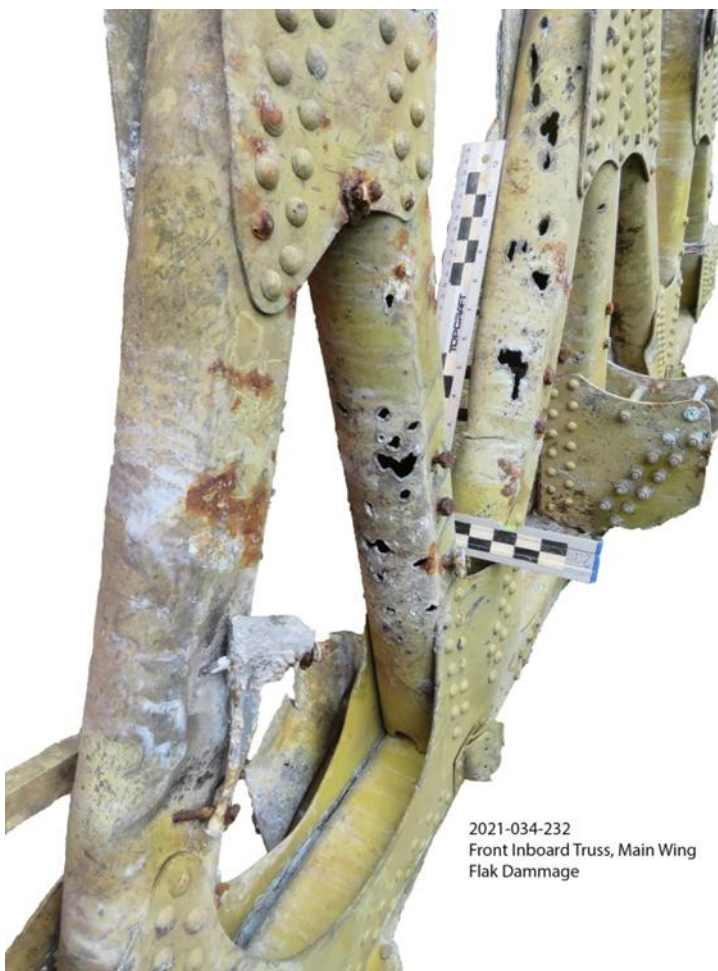
Plt-13, Shrapnel damage, wing truss support

2021-034-232  
Front Inboard Truss, Main Wing  
Flak Dammage

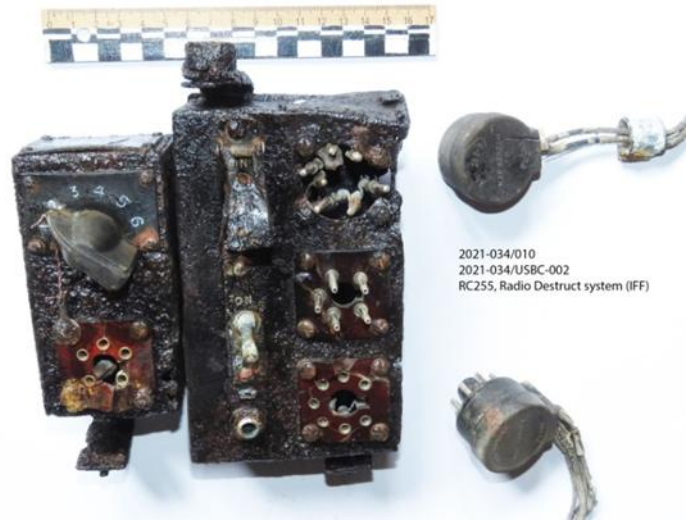
Plt-15, Identifier Friendly Foe (IFF) Destruct

2021-034/010  
2021-034/USBC-002  
RC255, Radio Destruct system (IFF)

Also found is a radio transmitter, antenna transmitter unit, the IFF destruct system for the radio, and a part of the Radio Operators' chair. This is very important as being from the Radio Operators section, and is extremely important as one of the missing airmen is our Radio Operator. This evidence gives hope that he may be very well on the impact point – not in the deposited crater.

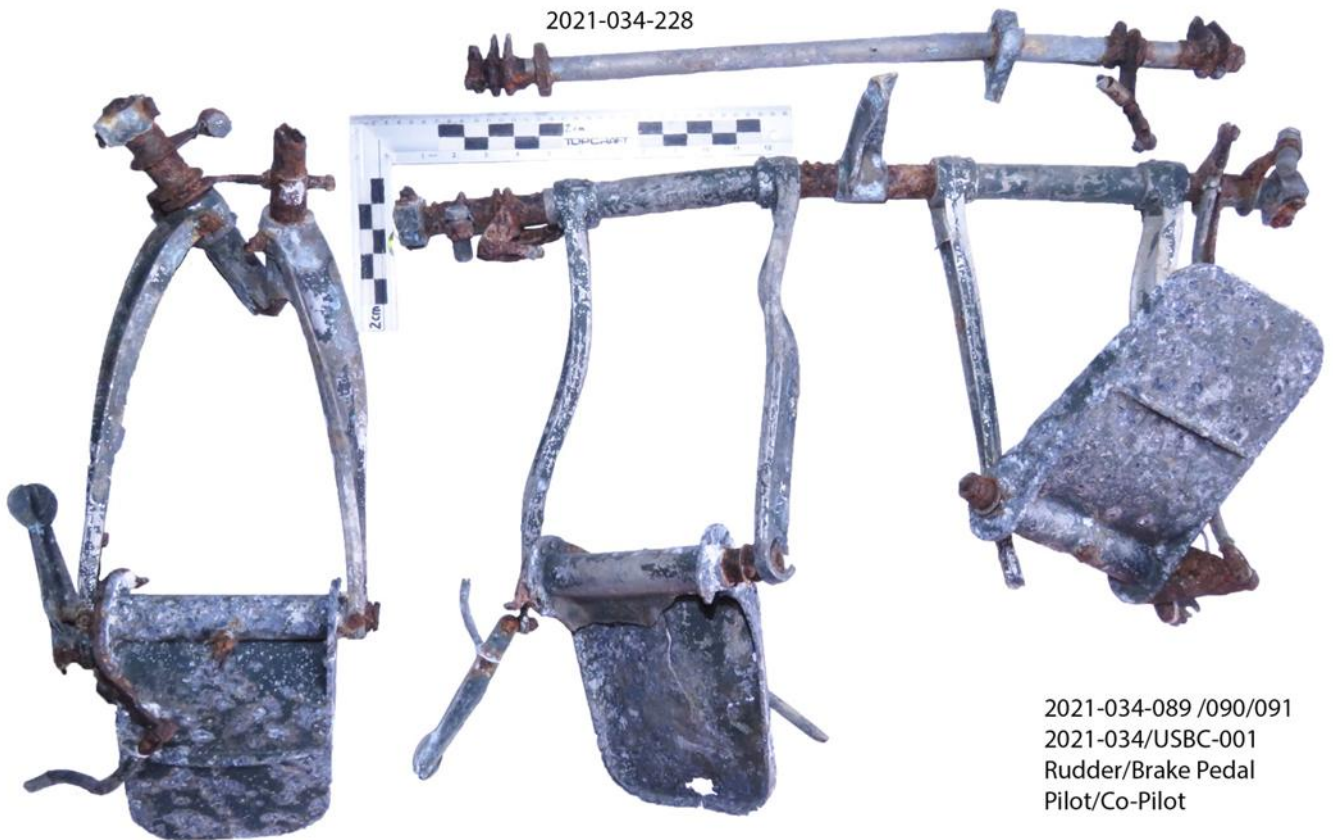
Plt-16, Rudder/brake pedals

2021-034-089 /090/091  
2021-034/USBC-001  
Rudder/Brake Pedal  
Pilot/Co-Pilot
